## INSPECTION REPORT PART (IRP)

<b>INSPECTION NO FOR CLIENT REFERENCE:</b>	COFAN
<b>PRODUCT NAME / ITEM NUMBER:</b>	TROUSER (1100208)
<b>COLOR</b>	DARK BLUE
<b>PO NUMBER:</b>	N/A
<b>ORDER QUANTITY</b>	2560 PCS
<b>CHECKED QUANTITY</b>	125 PCS
<b>INSPECTION DATE:</b>	12/02/2024
<b>FACTORY DETAILS:</b>	VINIT GLOVES

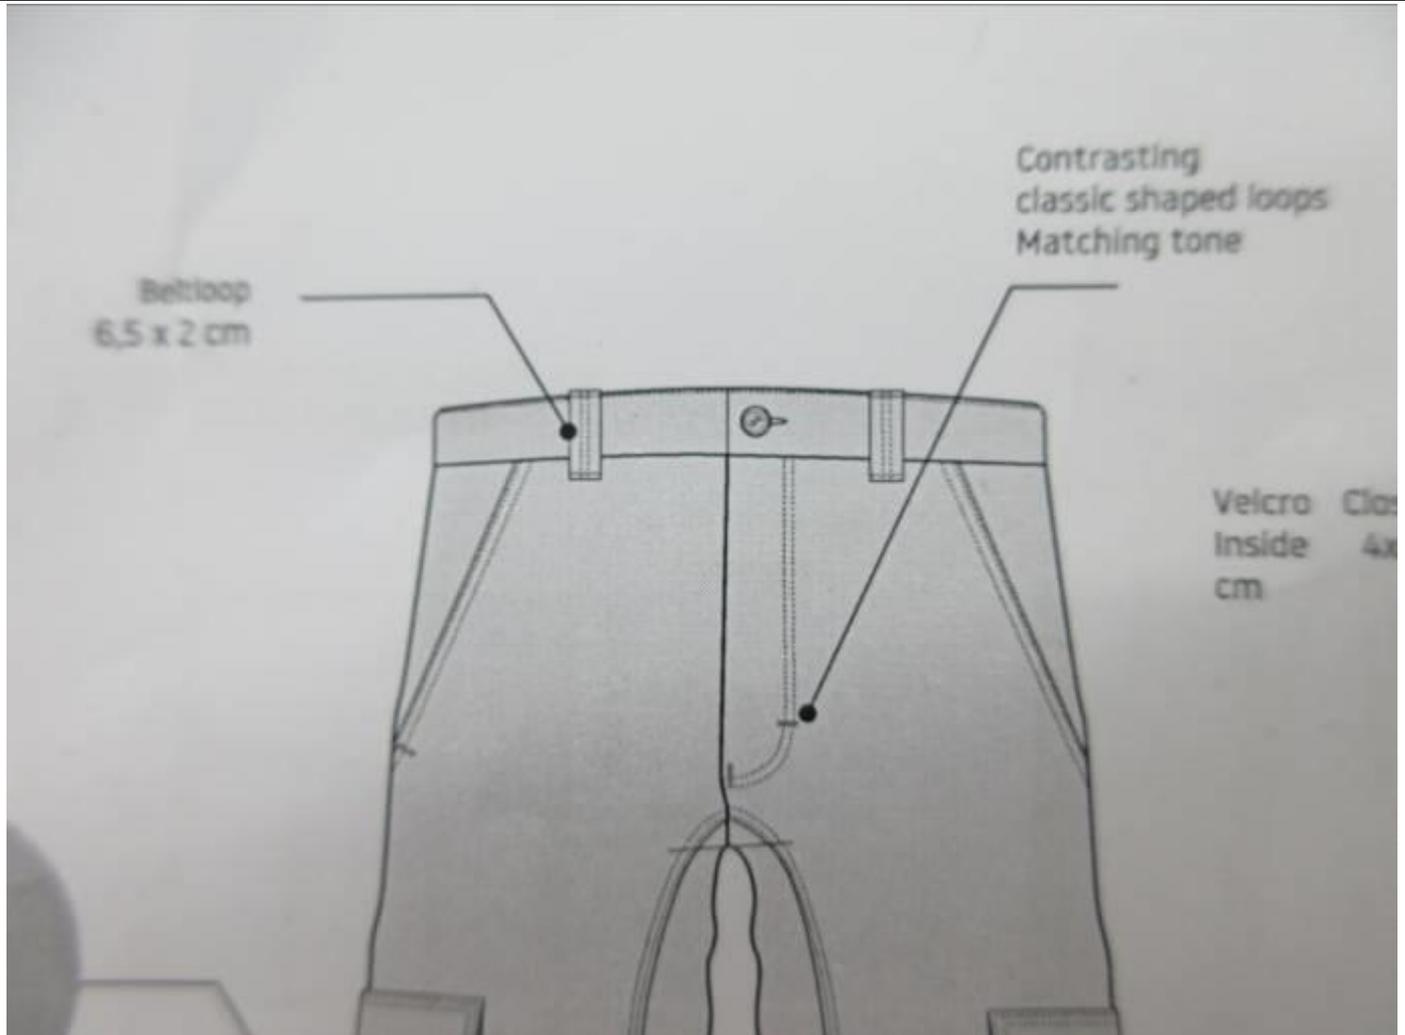
**TECHNICAL PACKAGE AGAINST REMARK NO. 3**

1. **FACTORY PROVIDED 100% (2560 PCS) IN 256 CARTONS FOR CHECKING**
2. **NO CLIENT APPROVED SAMPLE PROVIDED BY THE FACTORY EXCEPT THE TECHNICAL SHEET AND TRIM DETAILS.**
3. **AS PER THE TECHNICAL PACKAGE THERE SHOULD BE A BARTACK ON THE FLY OF ZIPPER WHICH IS FOUND MISSING IN BULK PRODUCT, FACTORY NEED TO VARRIFY BEFORE FINAL SHIPPING.**
4. **DIMENSION OF THE PRODUCT IS FOUND SATISFACTORY AGAINST THE FACTORY PROVIDED SPEC SHEET EXCEPT #HALF THIGH (10 CM FROM) IS NOT UPTO THE MARK AGAINST THE TECHNICAL PACKAGE, FACTORY NEEDS TO BE RE-CONFIRMING THE POINT BEFORE SHIP.**

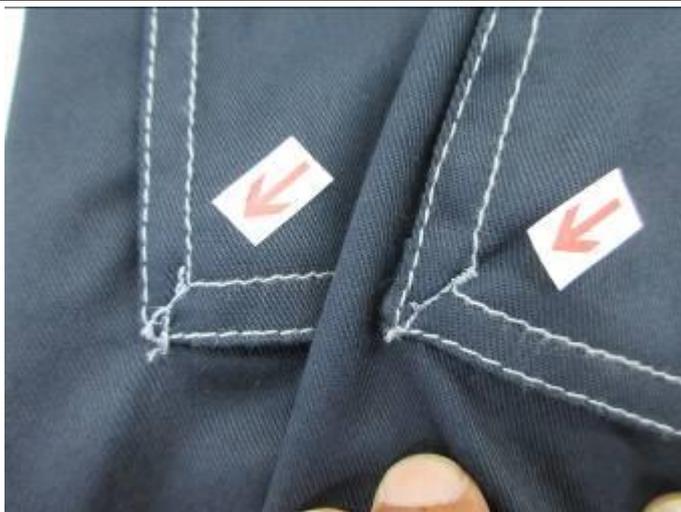
**BARTACK MISSING**

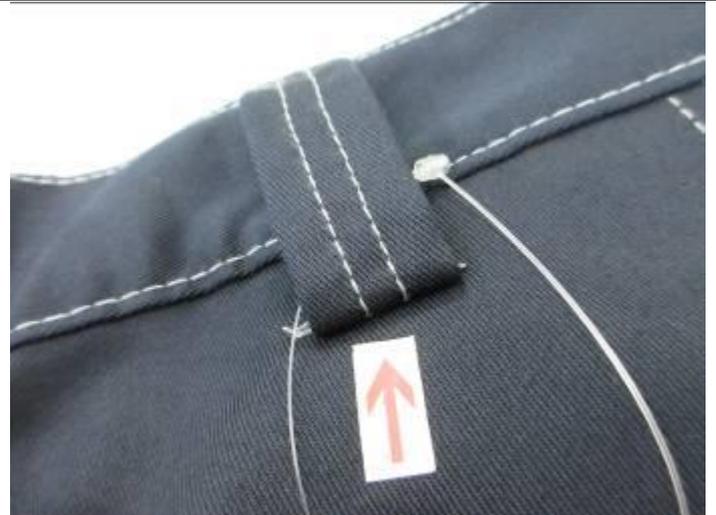
**BARTACK MISSING**

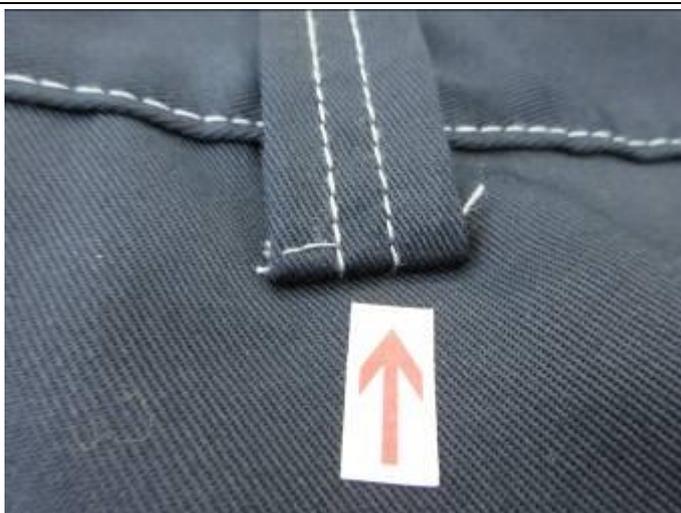
**BARTACK MISSING**

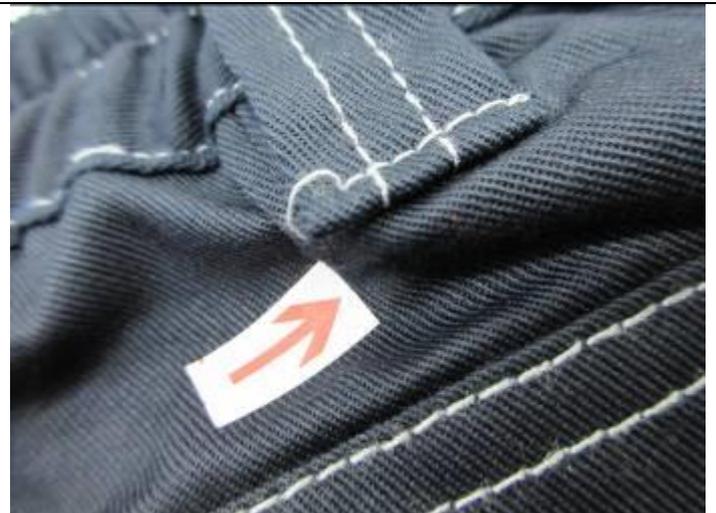
**BARTACK MISSING**

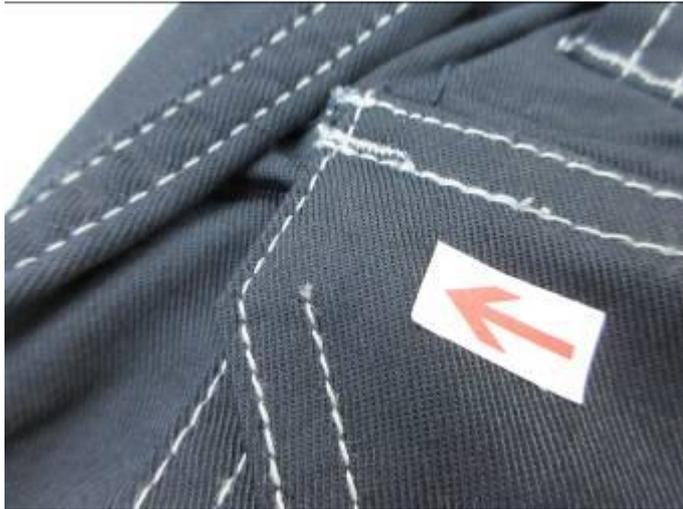
**MISSING STITCH**

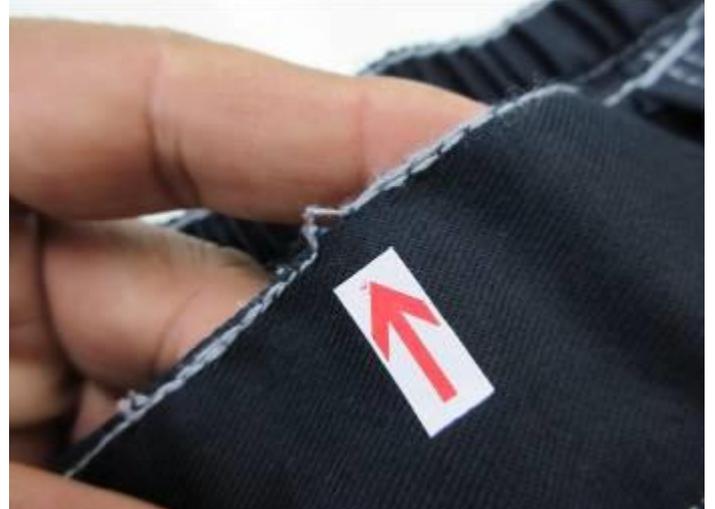
**BROKEN STITCH**

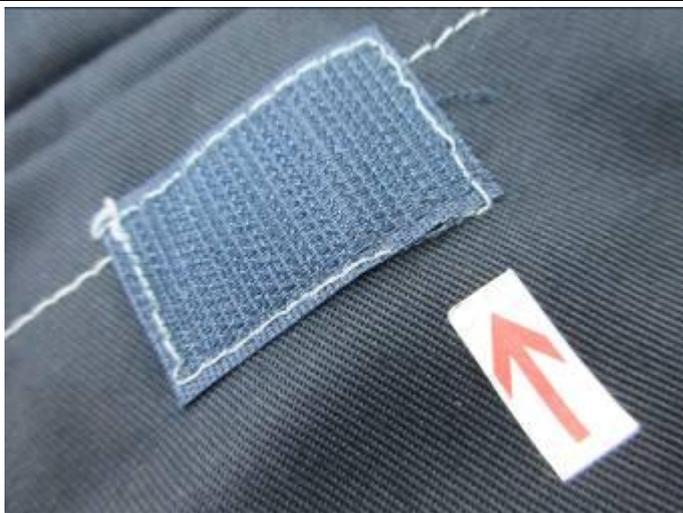
**INSECURE STITCH**

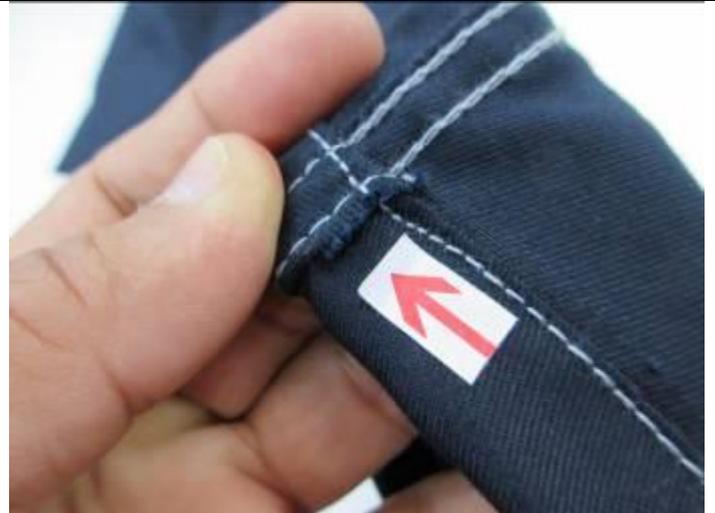
**INSECURE MARGIN(RAW EDGES)**
