## INSPECTION REPORT PART (IRP)

INSPECTION NO FOR CLIENT REFERENCE:	ATI
PRODUCT NAME:	Leather Bags
PO NUMBERE:	2115570
INSPECTION DATE:	15/December/2021
INSPECTION LOCATION:	Kolkata
INSPECTOR NAME:	Debanjan Talapatra & team
FACTORY DETAILS:	Edcons Exports Pvt. Ltd.
CUSTOMER NAME :	Porsche Bags

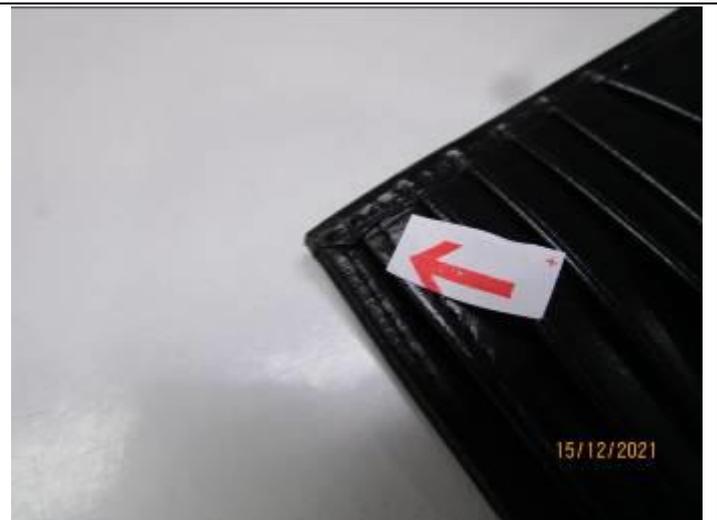
DEFECT 1. BROKEN SEAM

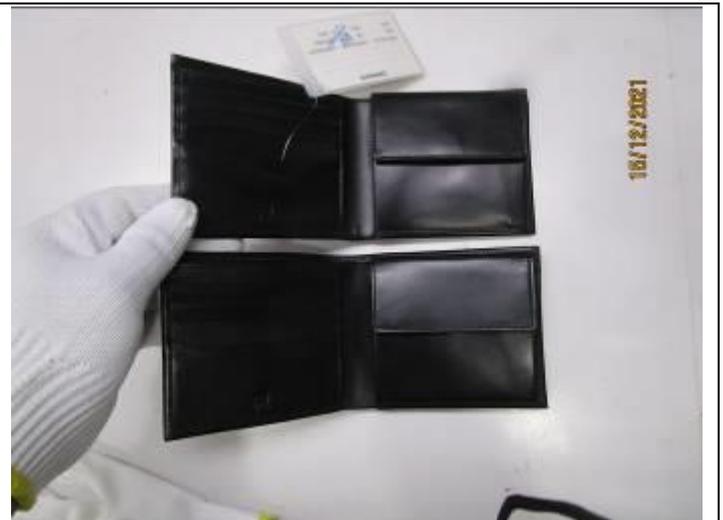
DEFECT 1: INSECURE STITCH

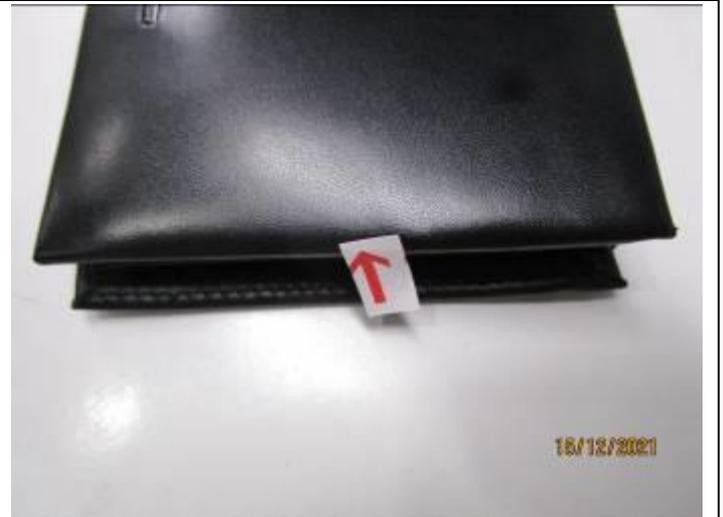
DEFECT 2: UNSYMETRICAL EDGE

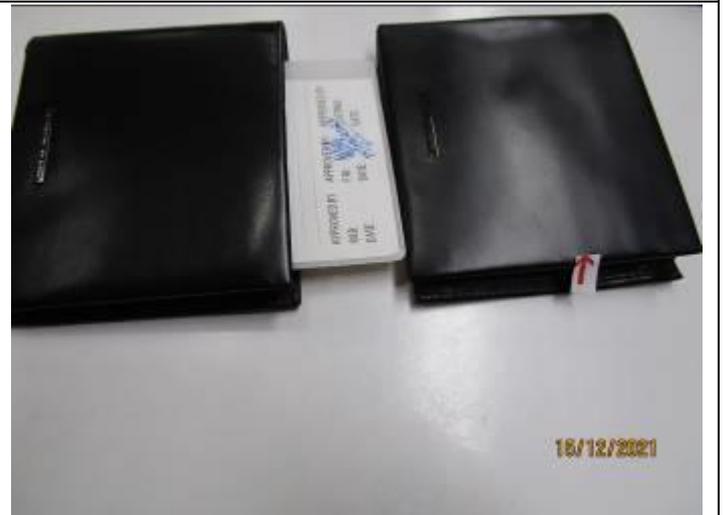
COMPARISON WITH SAMPLE OF FOUND DEFECT

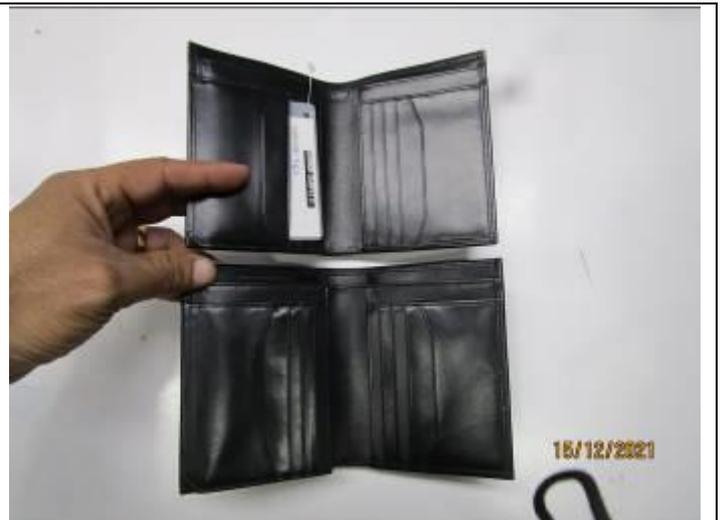
DEFECT 1: IMPROPER MANUFACTURING

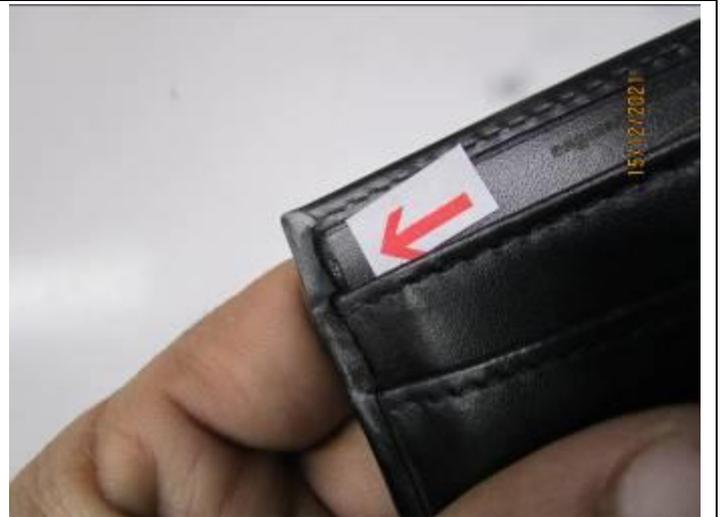
DEFECT 2: INSECURE PASTING

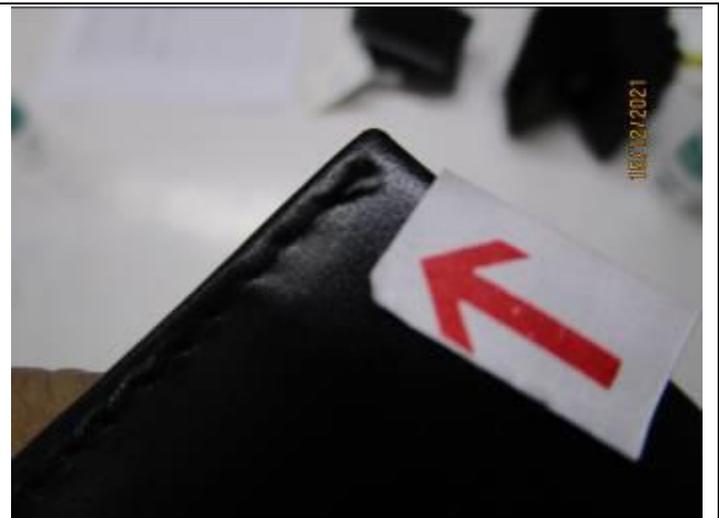
DEFECT 1: BROKEN SEAM

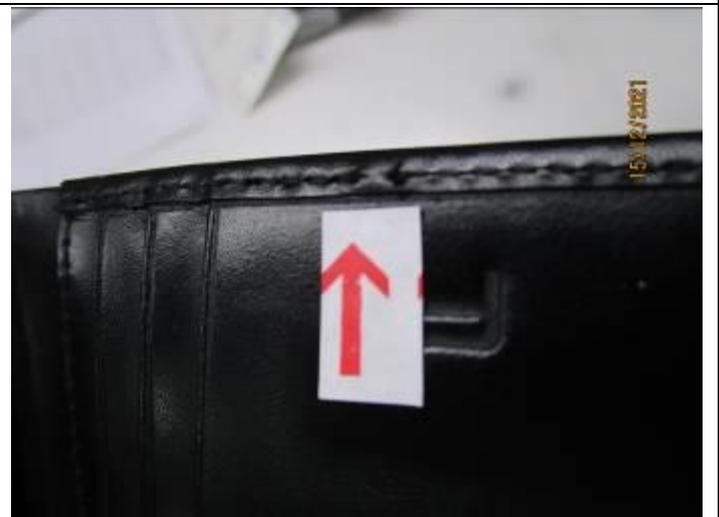
DEFECT 3: BROKEN SEAM

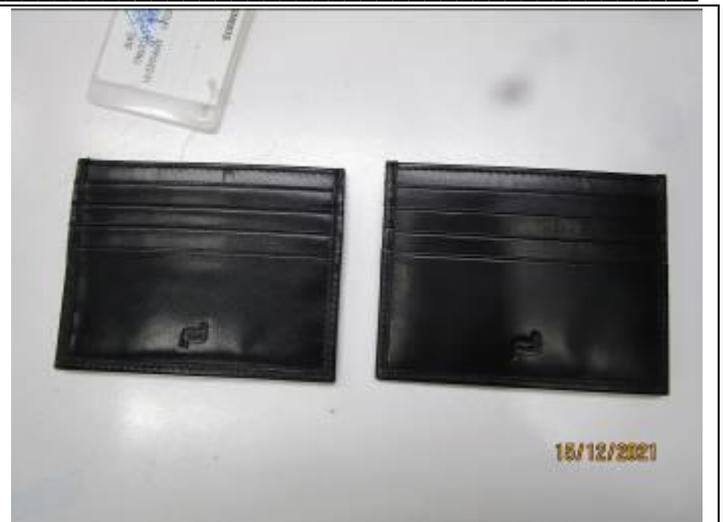
DEFECT 1. IMPROPER FINISHING OF SIDE

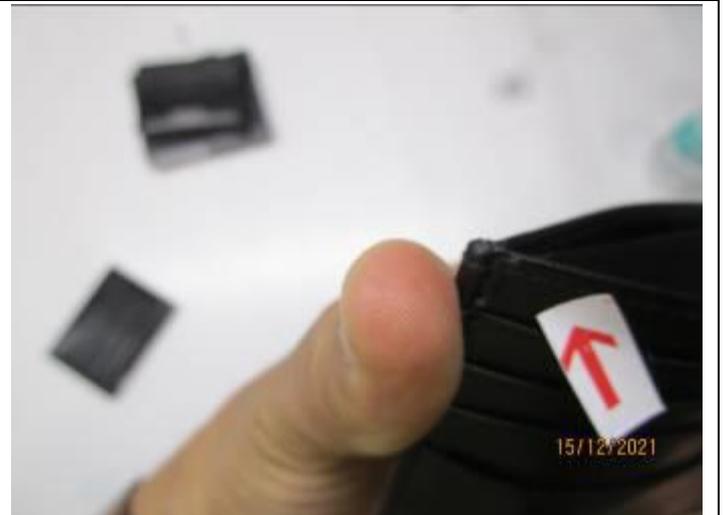
DEFECT 2. IMPROPER EDGING

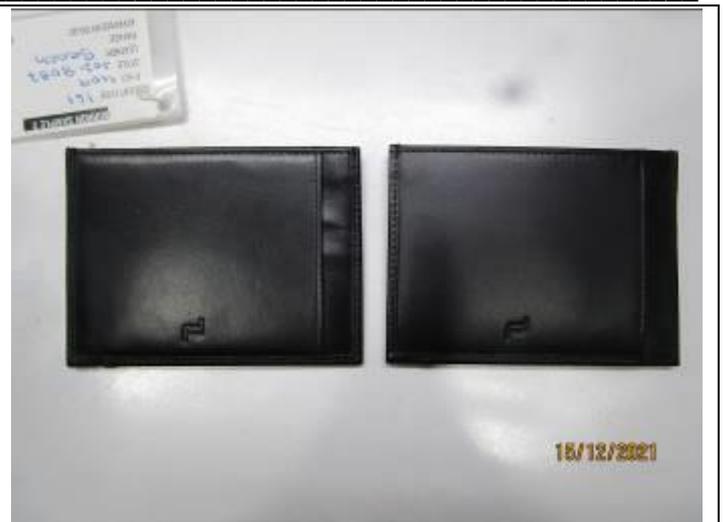
DEFECT 1: SCRATCH MARK

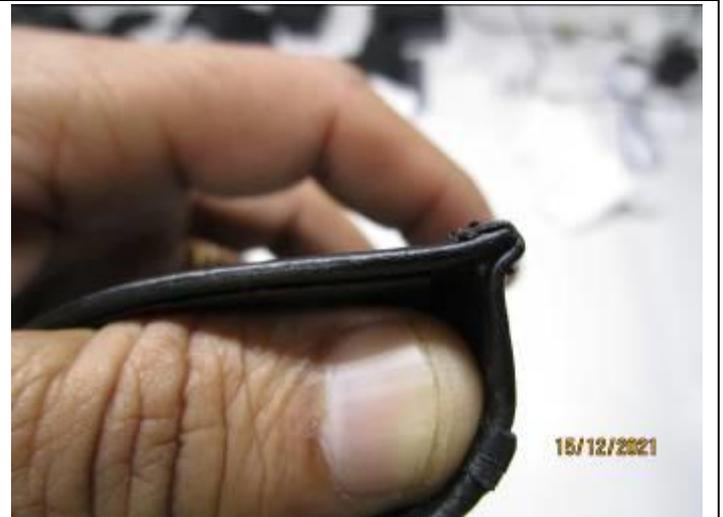
DEFECT 2: INSECURE LOCKING ON EDGE JOINT

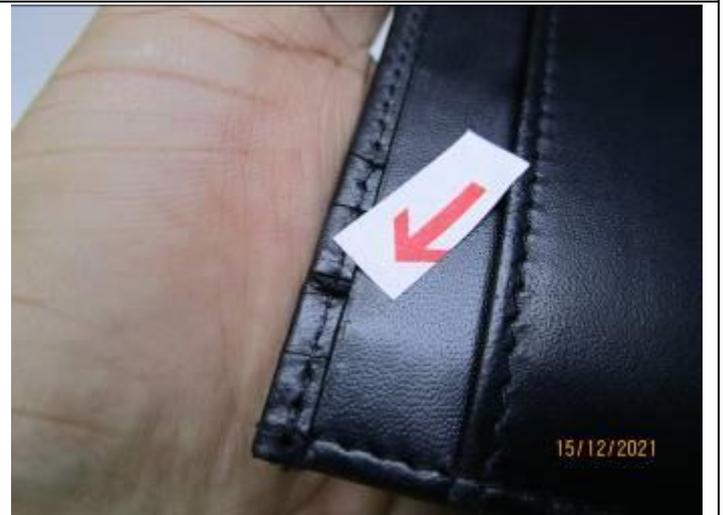
DEFECT 4: RAW EDGE OF LEATHER ON JOINT

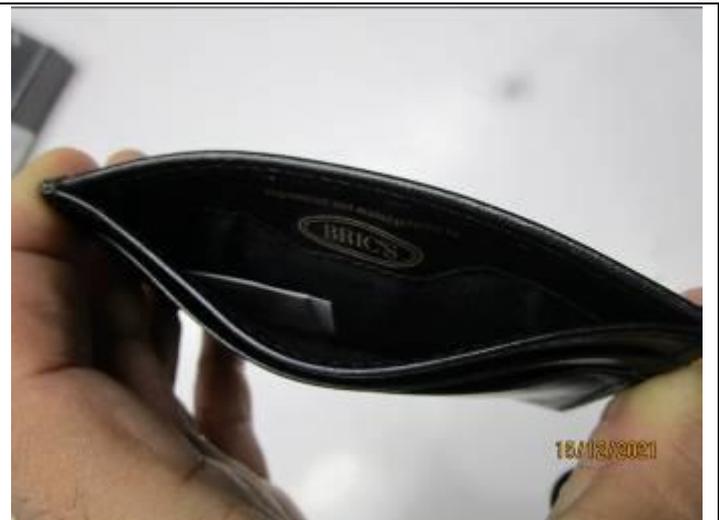
DEFECT 1: BROKEN STITCH

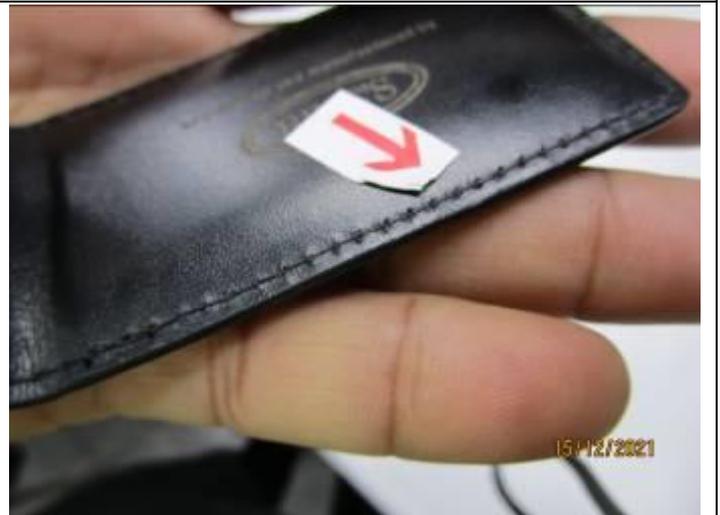
DEFECT 3: NEEDLE MARK VISIBLE
