## INSPECTION REPORT PART (IRP)

INSPECTION NO FOR CLIENT REFERENCE:	ATI
PRODUCT NAME:	Leather Bags
PO NUMBERE:	2115570
INSPECTION DATE:	15/December/2021
INSPECTION LOCATION:	Kolkata
INSPECTOR NAME:	Debanjan Talapatra & team
FACTORY DETAILS:	Edcons Exports Pvt. Ltd.
CUSTOMER NAME :	Porsche Bags

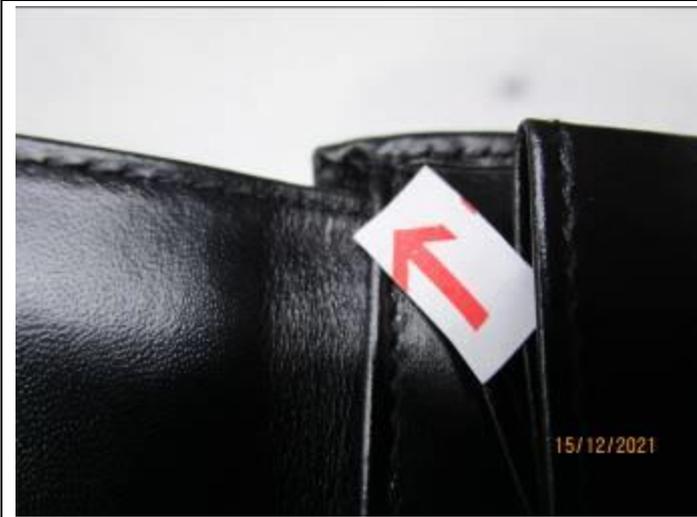
DEFECT 1: INSECURE STITCH

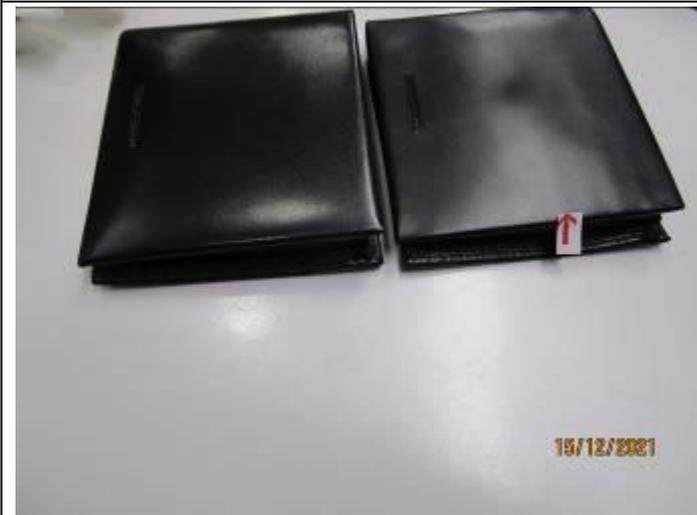
DEFECT 2: UNSYMETRICAL EDGE

COMPARISON WITH OTER BULK PRODUCT OF THE DEFECT

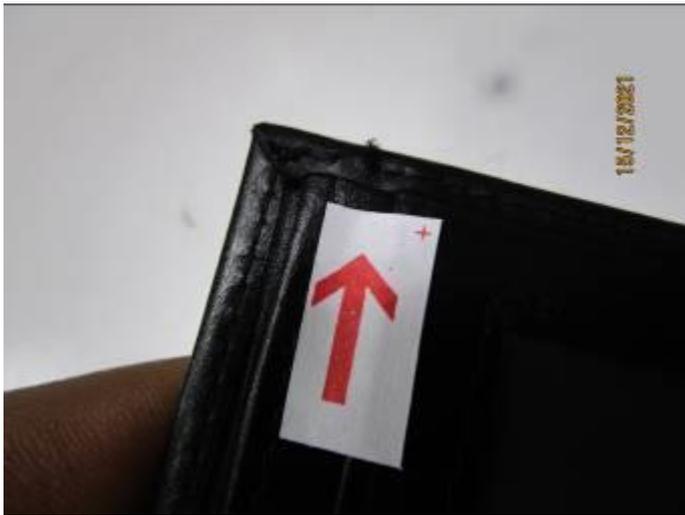
DEFECT 1: BROKEN SEAM

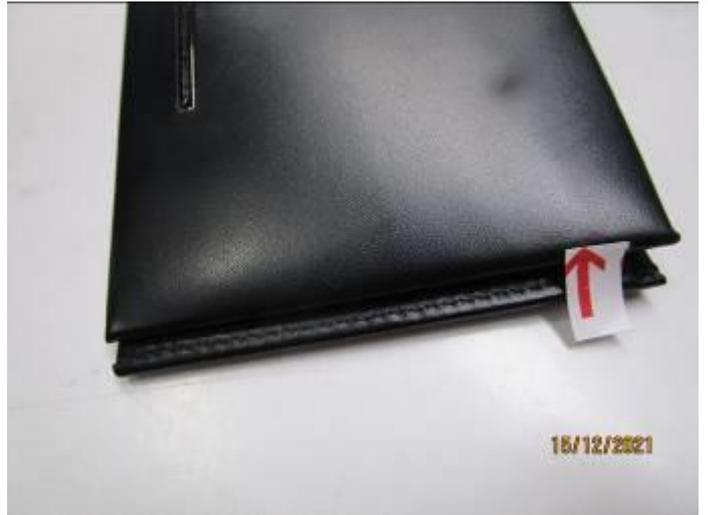
DEFECT 2: BROKEN SEAM

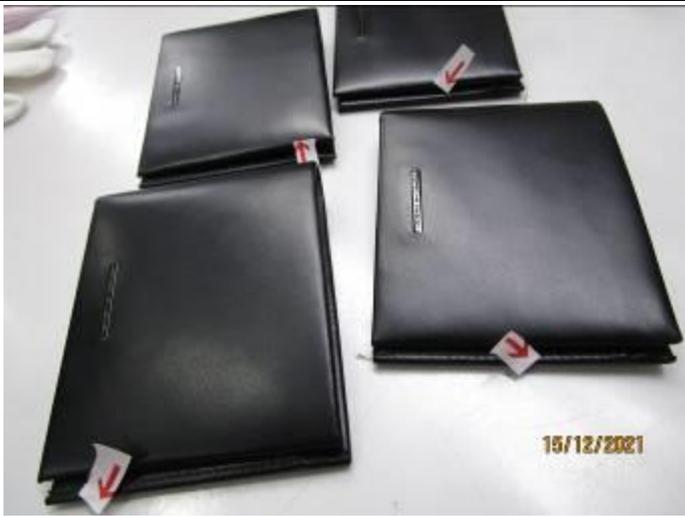
DEFECT 3: UNSYMETRICAL EDGE

ALL 4 PCS WITH SAME DEFECT AS DEFECT NO. 3

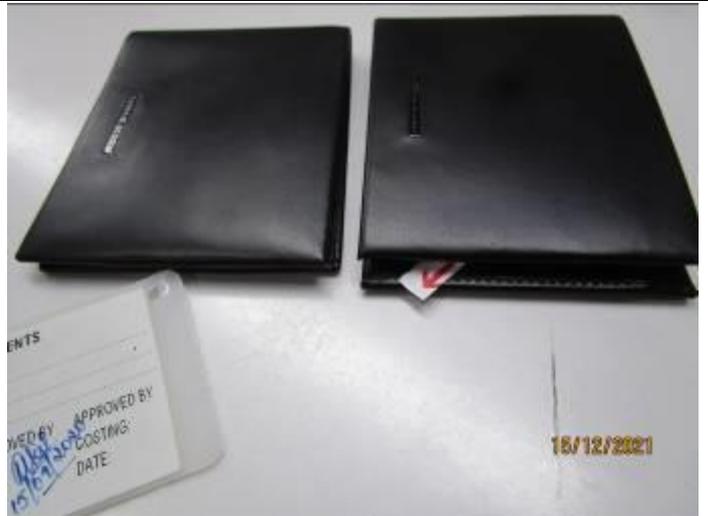
COMPARISON WITH SAMPLE OF FOUND DEFECT

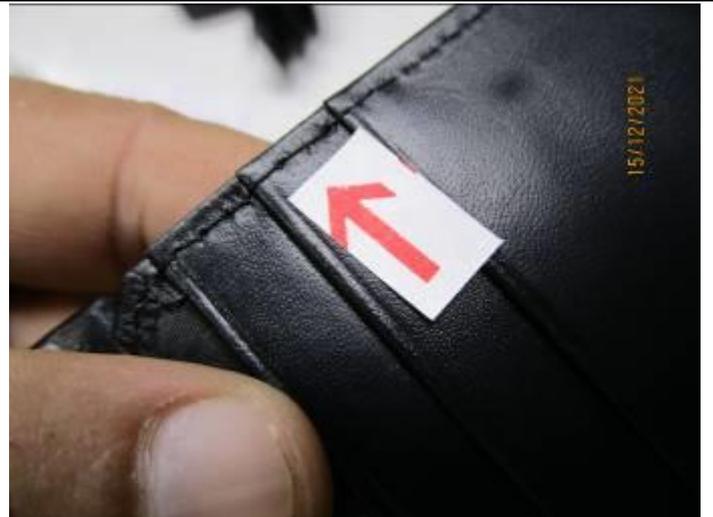
DEFECT 1: BROKEN SEAM

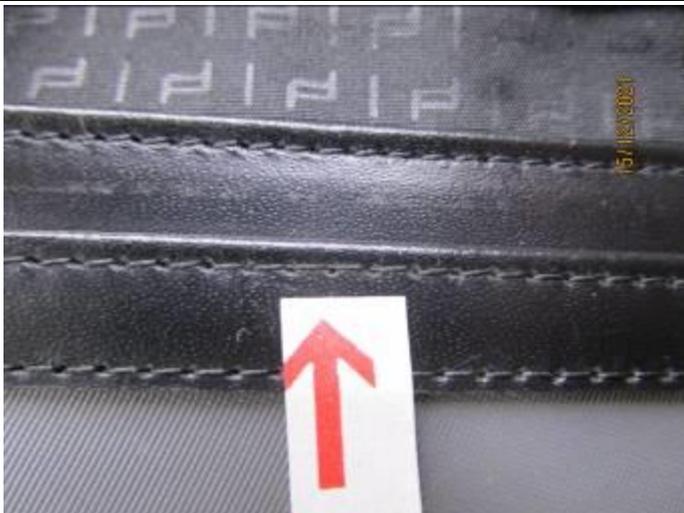
DEFECT 2: LONG SCRATCH MARK ON LEATHER

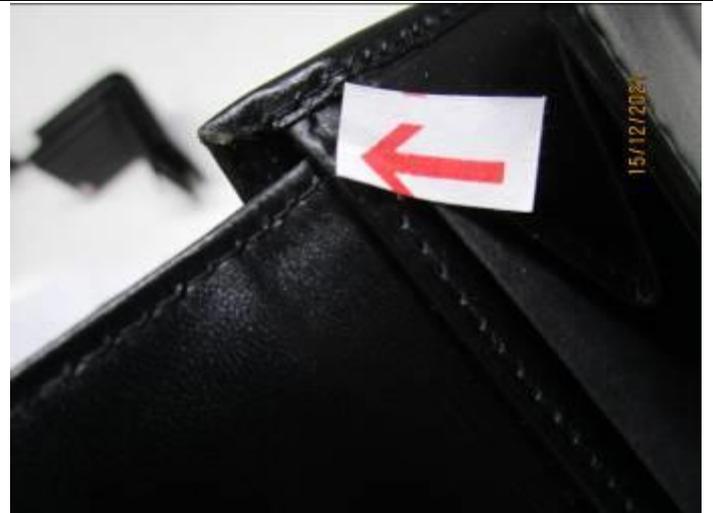
DEFECT 3: IMPROPER FINISHING

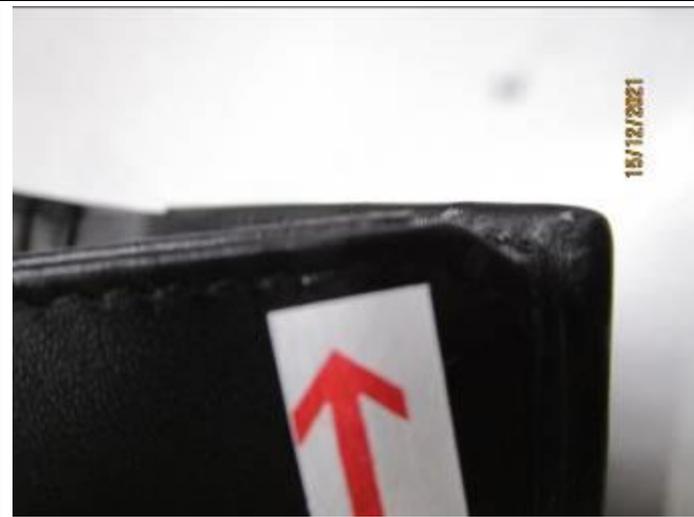
DEFECT 1: IMPROPER MANUFACTURING

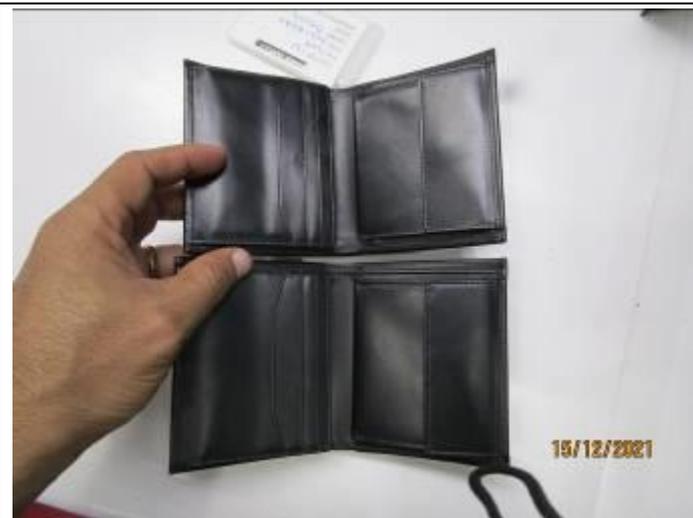
DEFECT 1: BROKEN SEAM

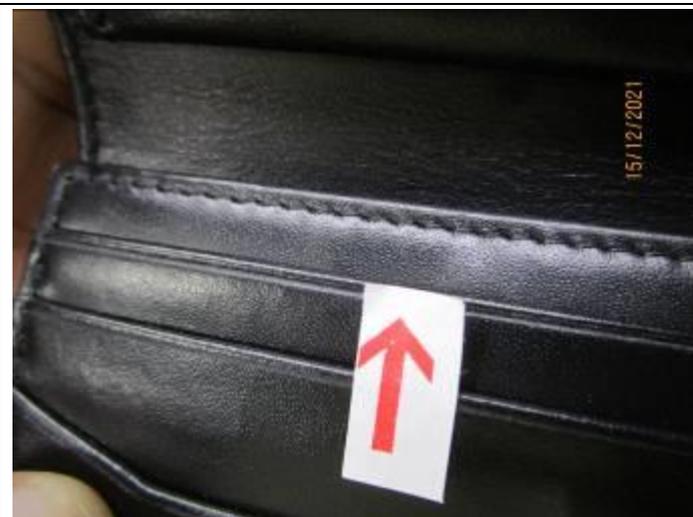
DEFECT 2: BULGING SURFACE

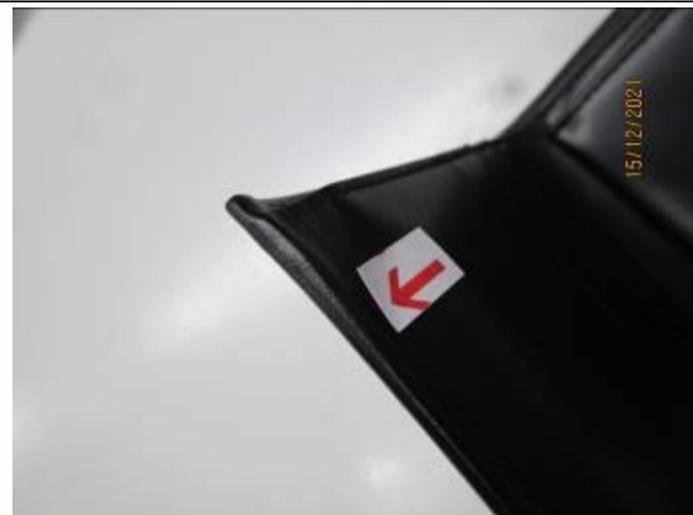
DEFECT 4: IMPROPER MANUFACTURING

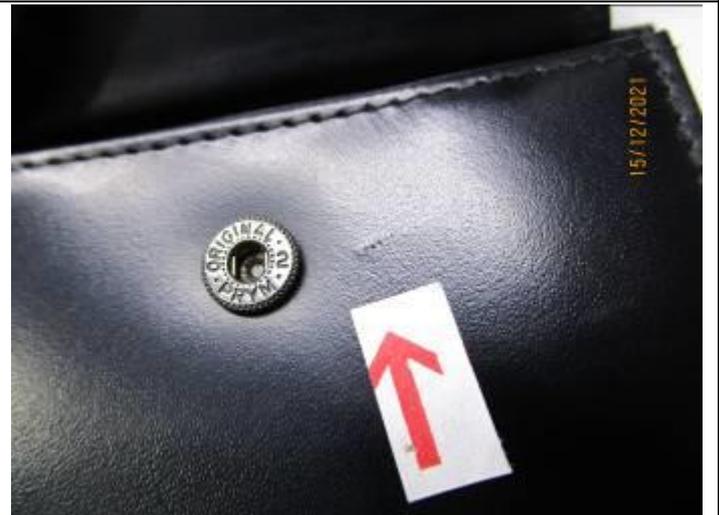
DEFECT 5: CUT MARK

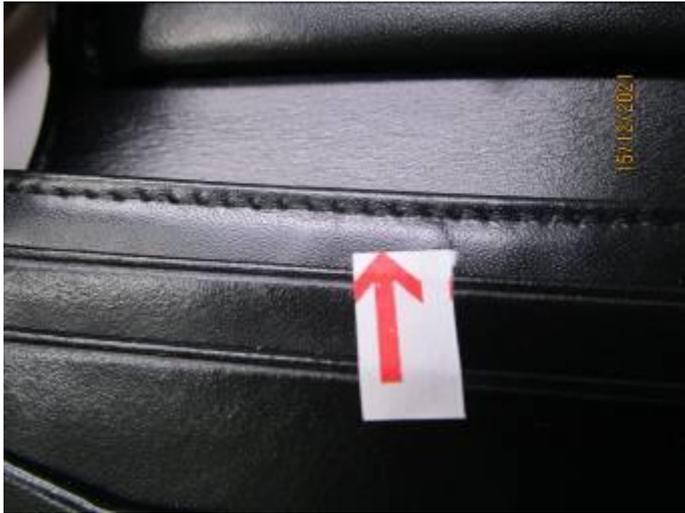
DEFECT 6: BULGING SURFACE

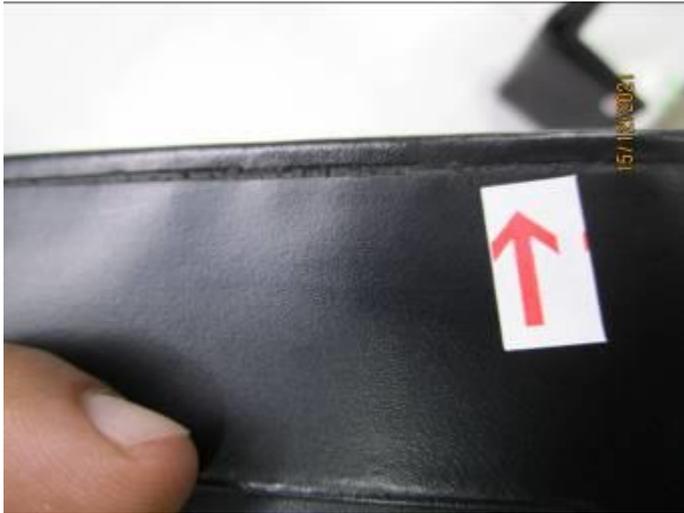
DEFECT 1: LEATHER SPOT

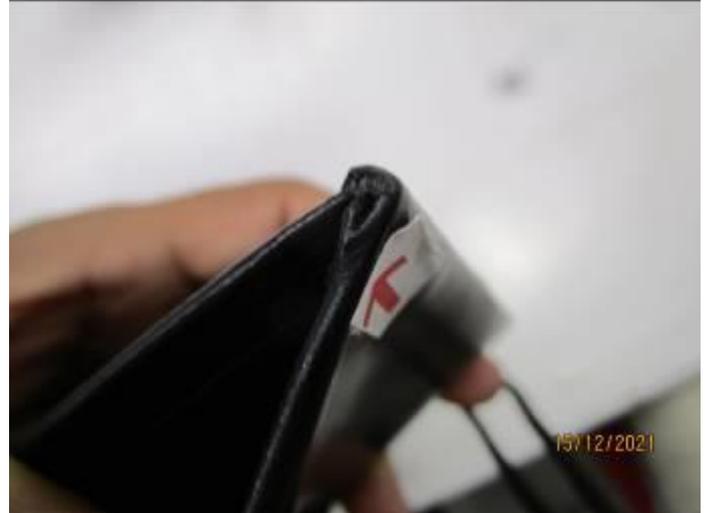
DEFECT 2: IMPROPER FINISHING

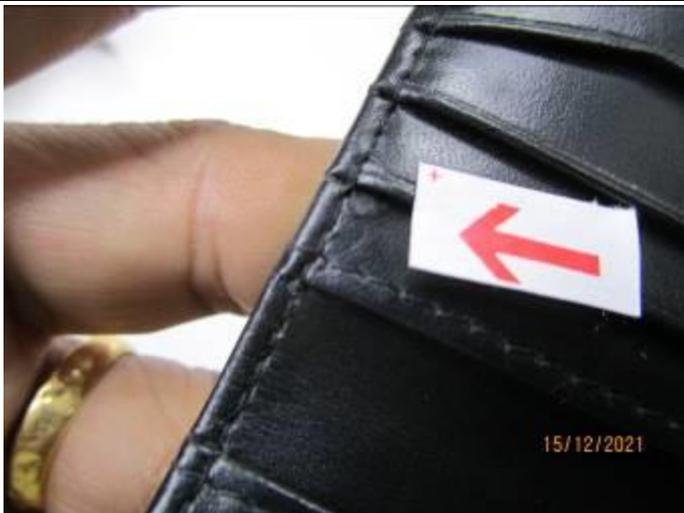
DEFECT 3: IMPROPER EDGE LOCKING

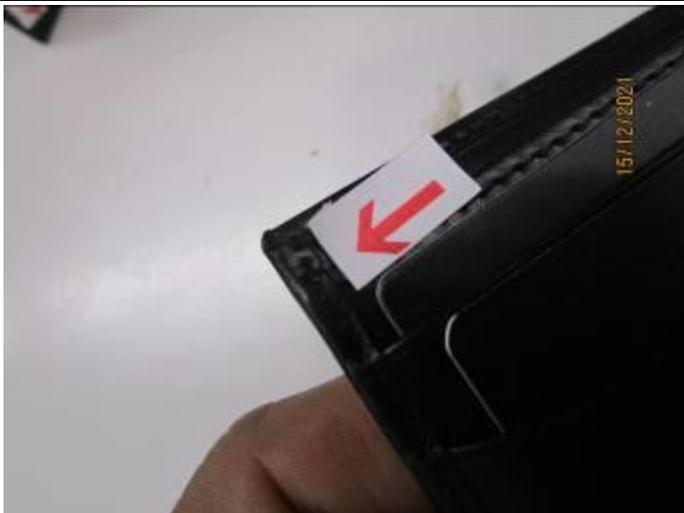
DEFECT 1: IMPROPER EDGE FINISHING

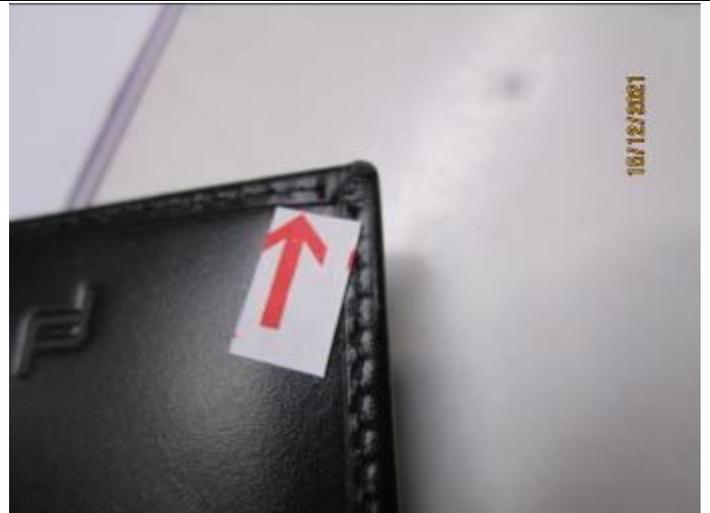
DEFECT 2: BROKEN SEAM

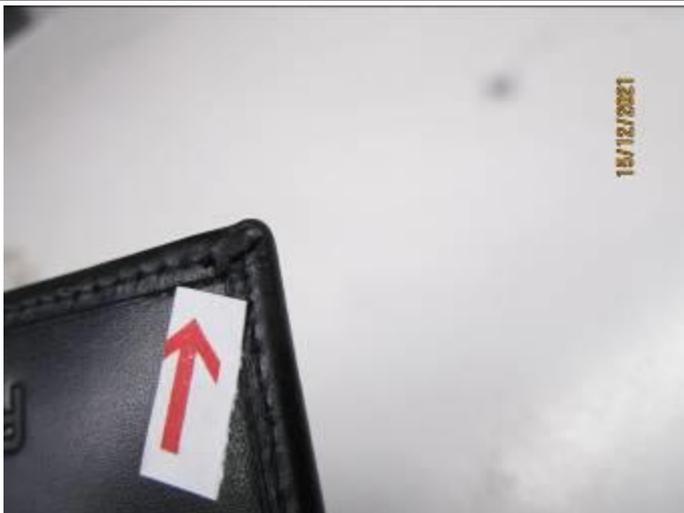
DEFECT 3: BROKEN SEAM

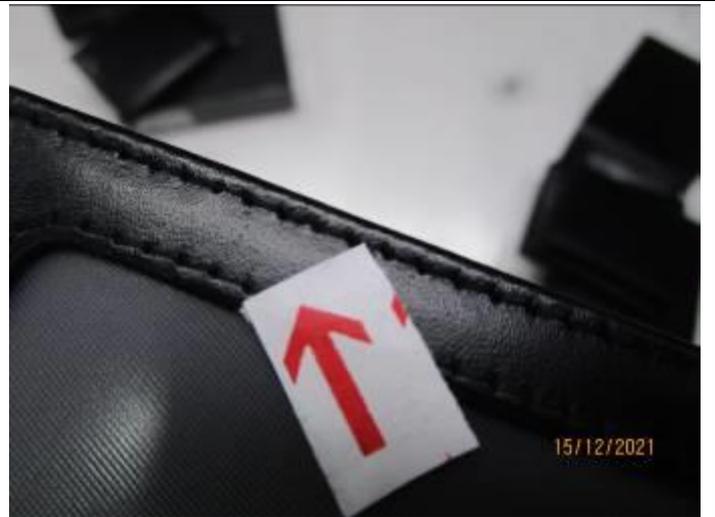
DEFECT 1: UNEVEN EDGING

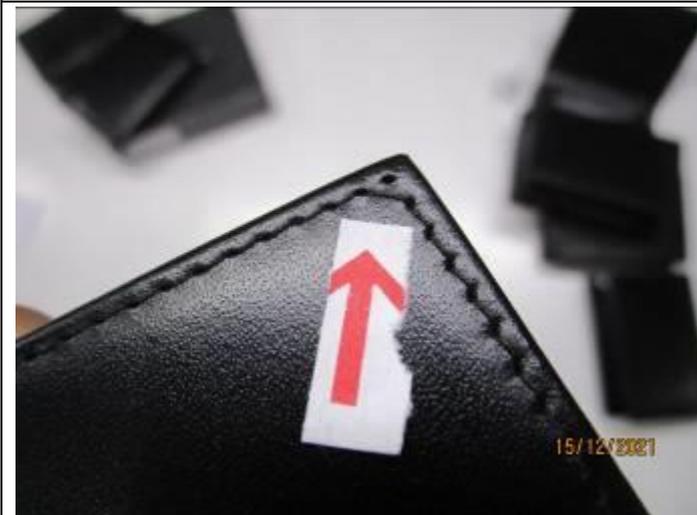
DEFECT 2: DIRT MARK ON LEATHER

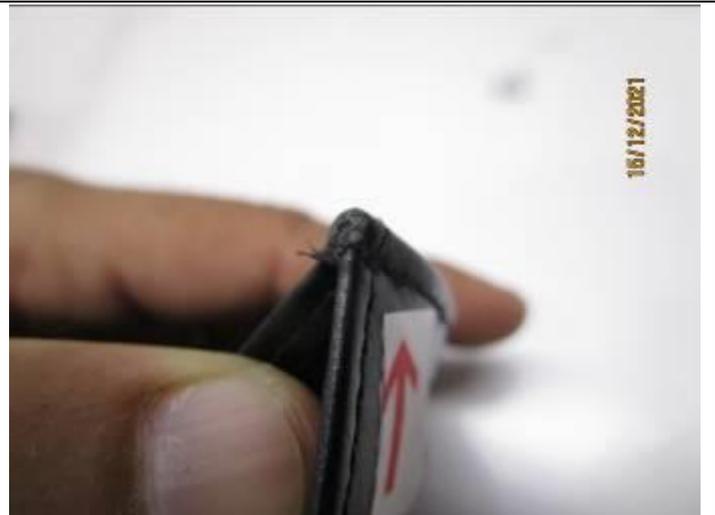
DEFECT 3: STITCH MISSING

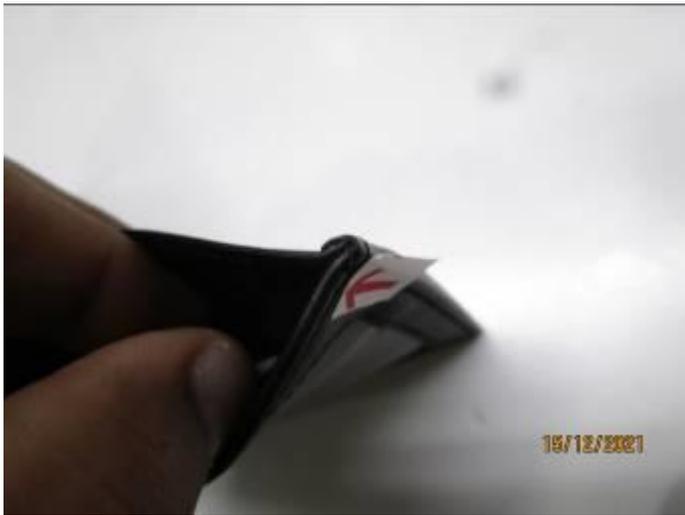
DEFECT 4: INSECURE EDGE JOINT

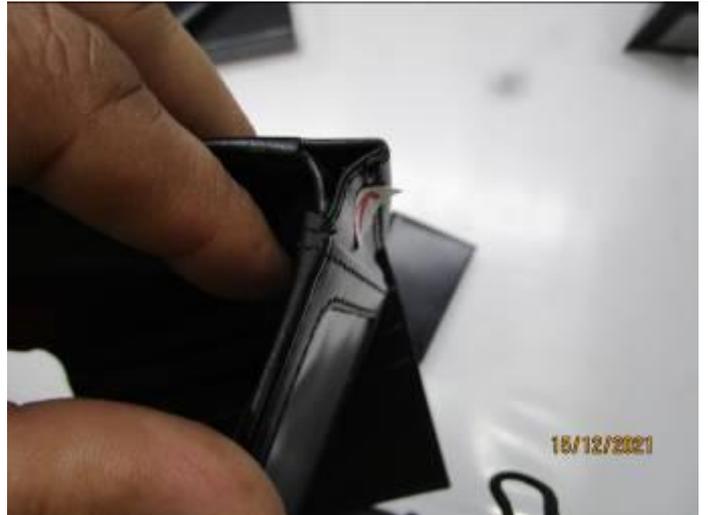
DEFECT 5: INSECURE EDGE JOINT

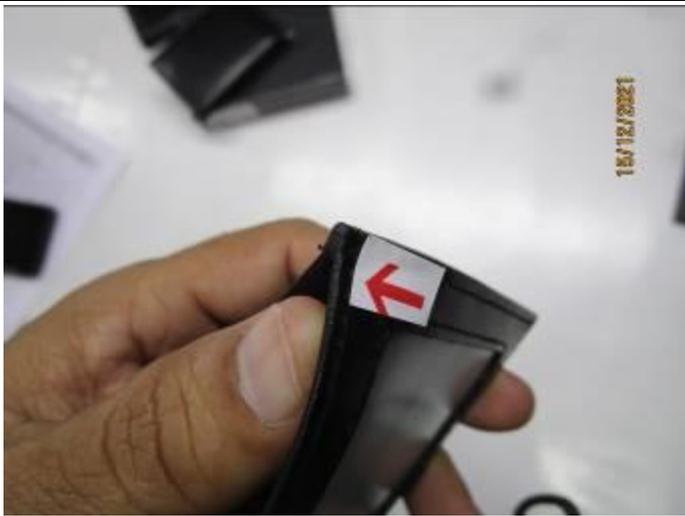
DEFECT 6: INSECURE EDGE JOINT

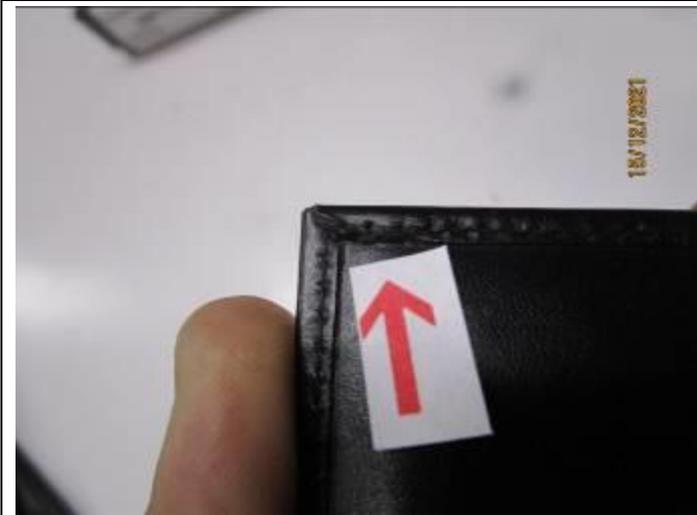
DEFECT 1. IMPROPER FINISHING OF SIDE

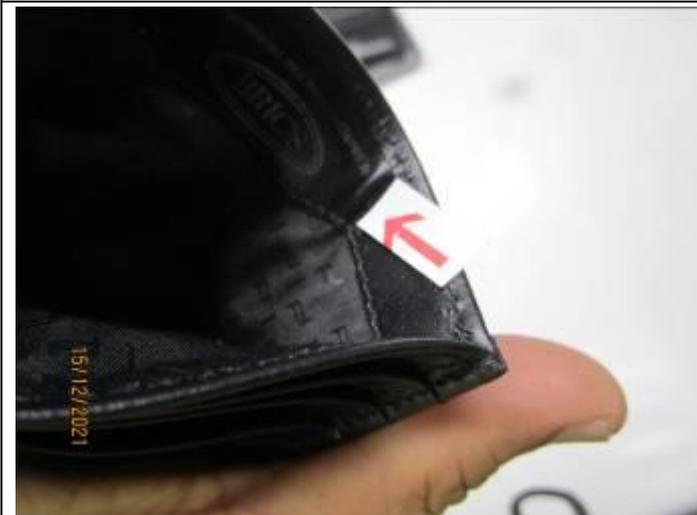
DEFECT 2. IMPROPER EDGING

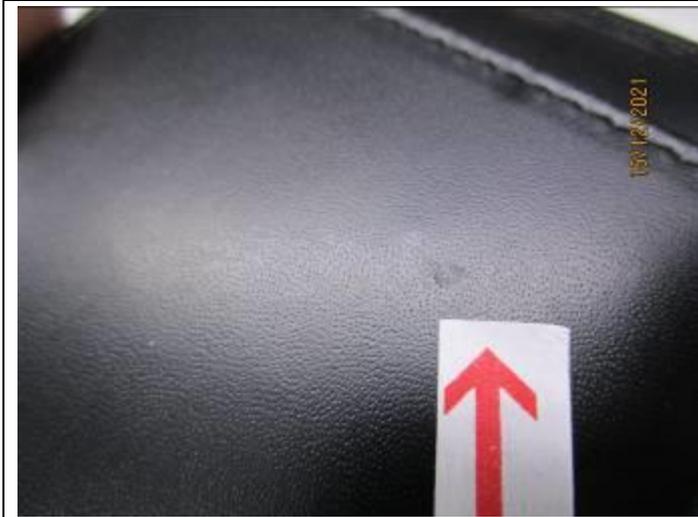
DEFECT 1: SCRATCH MARK

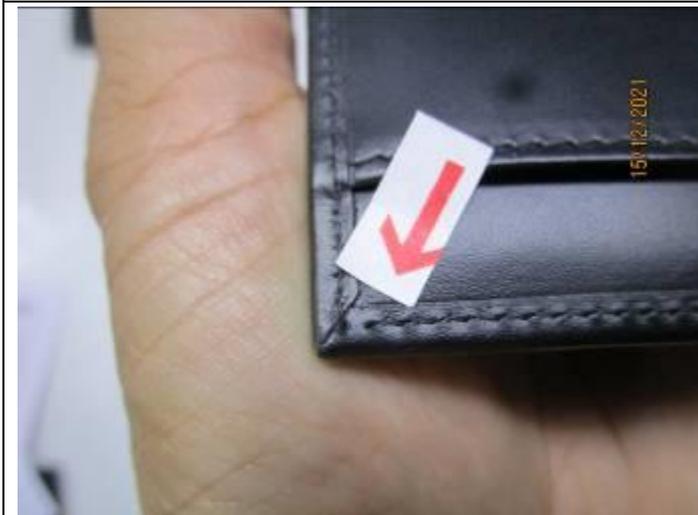
DEFECT 2: INSECURE LOCKING ON EDGE JOINT

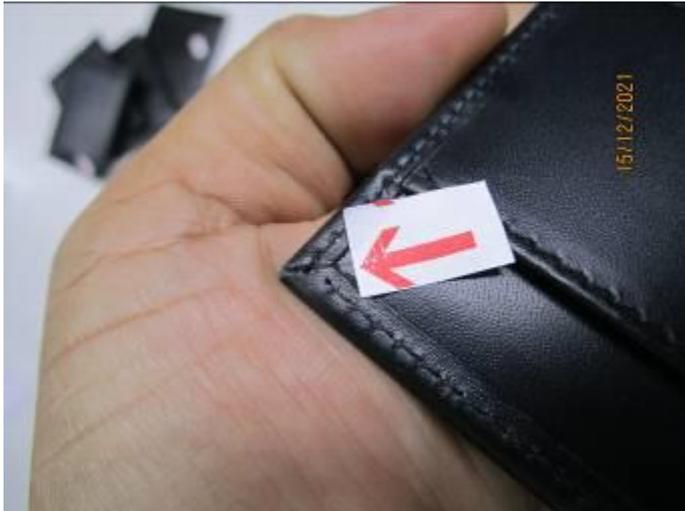
DEFECT 4: RAW EDGE OF LEATHER ON JOINT

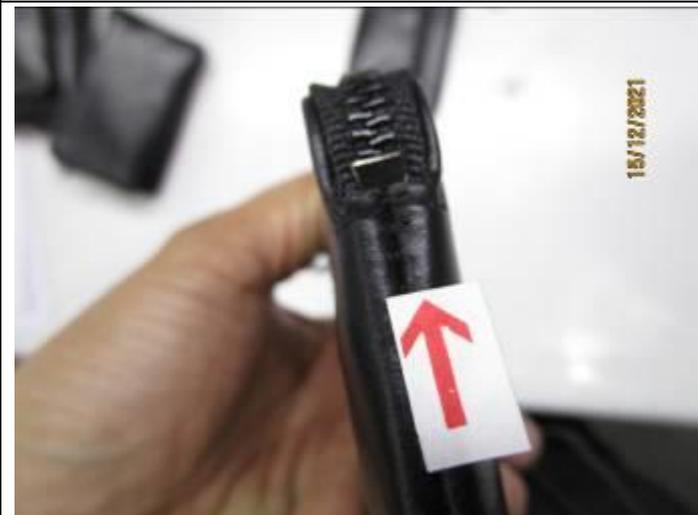
DEFECT 1: IMPROPER MANUFACTURING

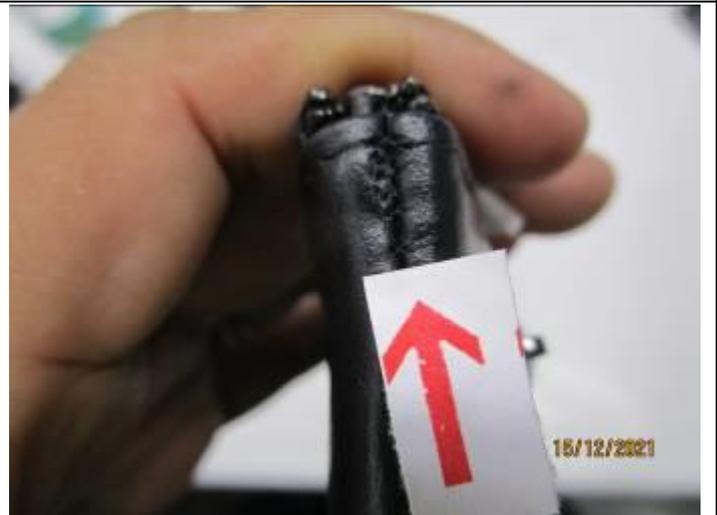
DEFECT 2: IMPROPER MANUFACTURING

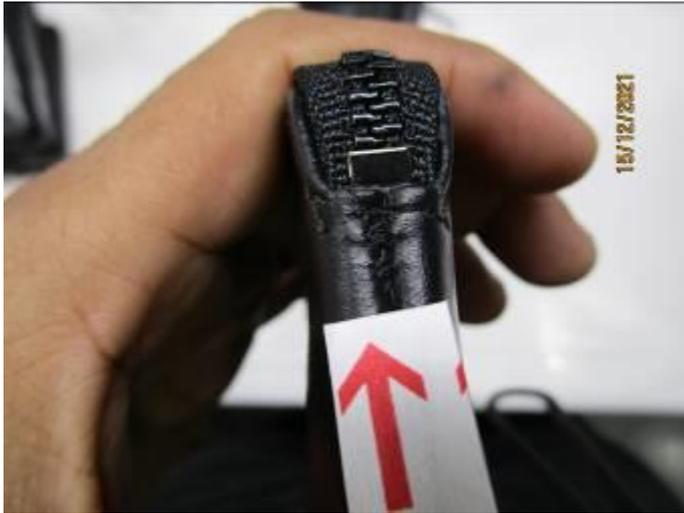
DEFECT 3: IMPROPER MANUFACTURING

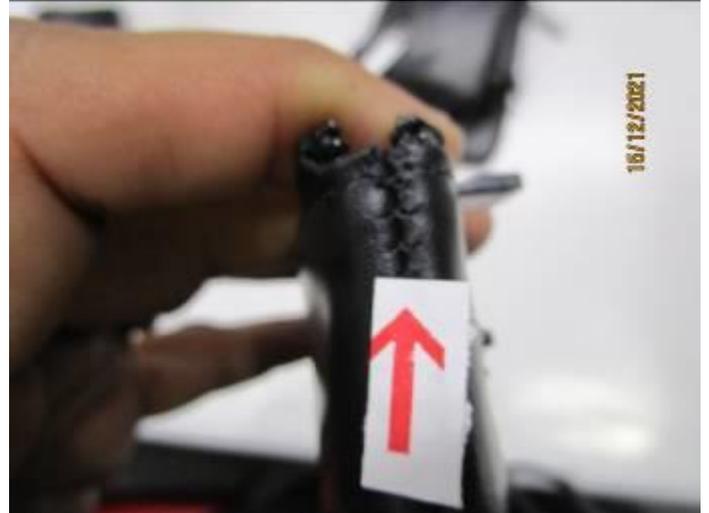
DEFECT 4: IMPROPER MANUFACTURING

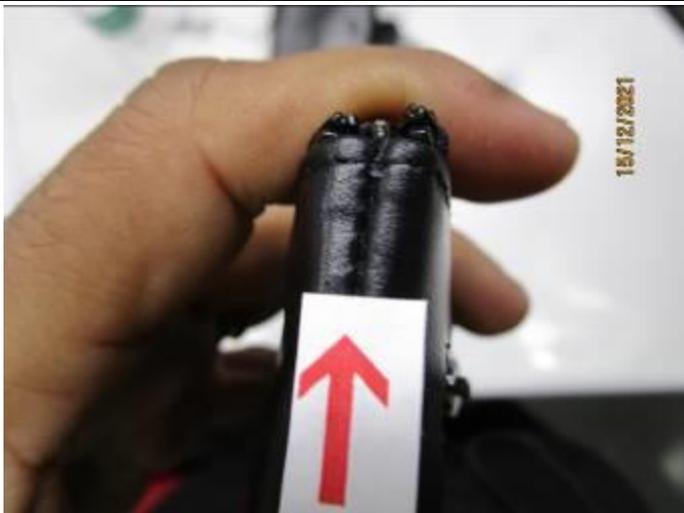
DEFECT 5: IMPROPER MANUFACTURING

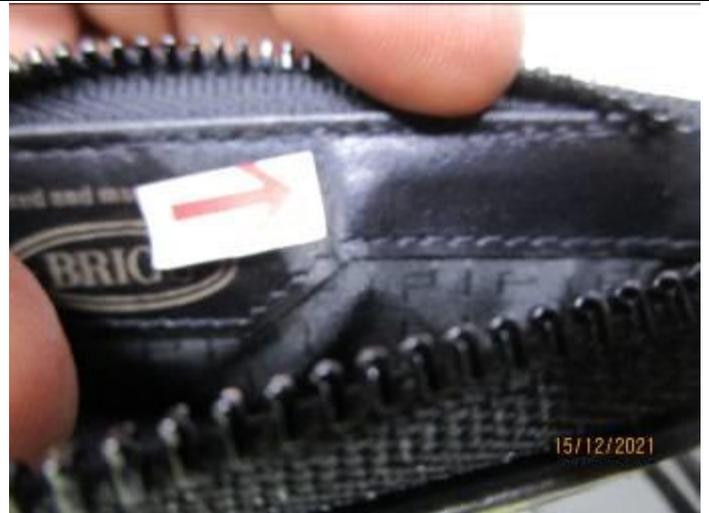
DEFECT 6: IMPROPER MANUFACTURING

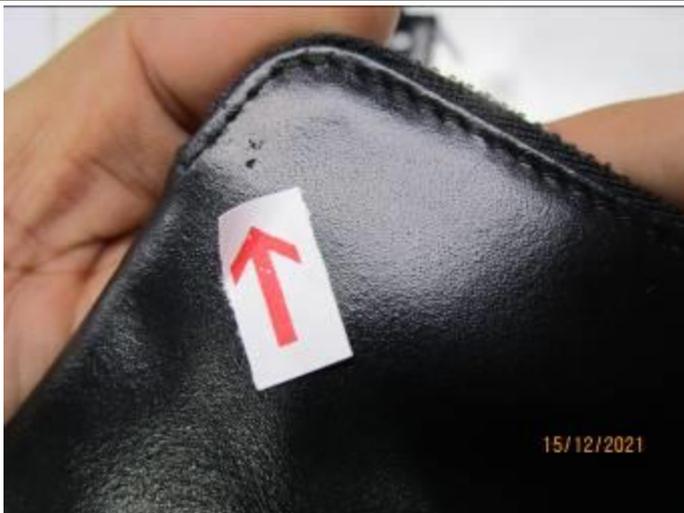
DEFECT 7: BULGING SURFACE

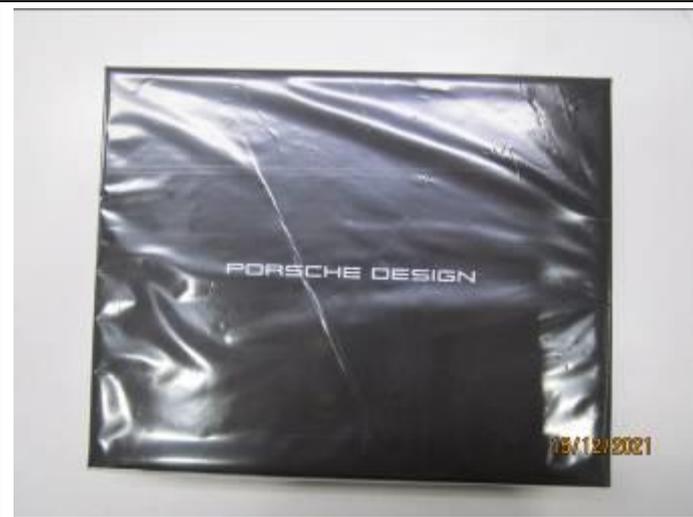
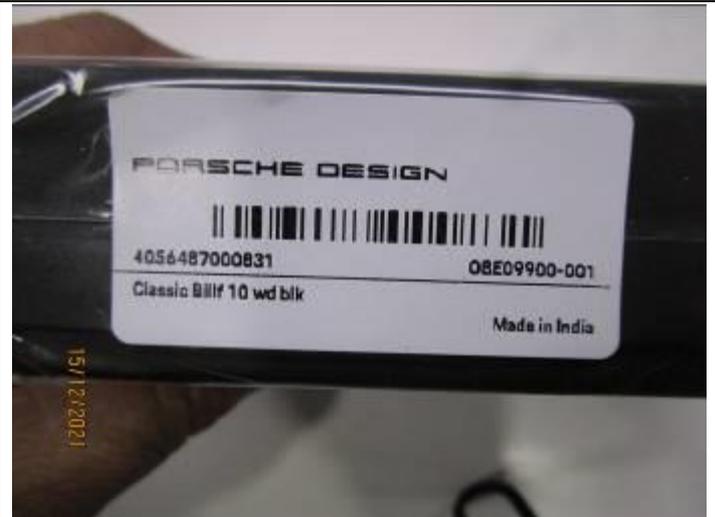
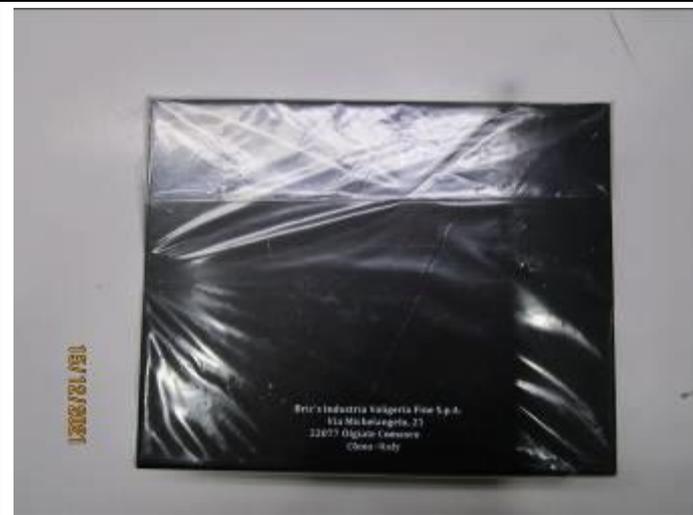
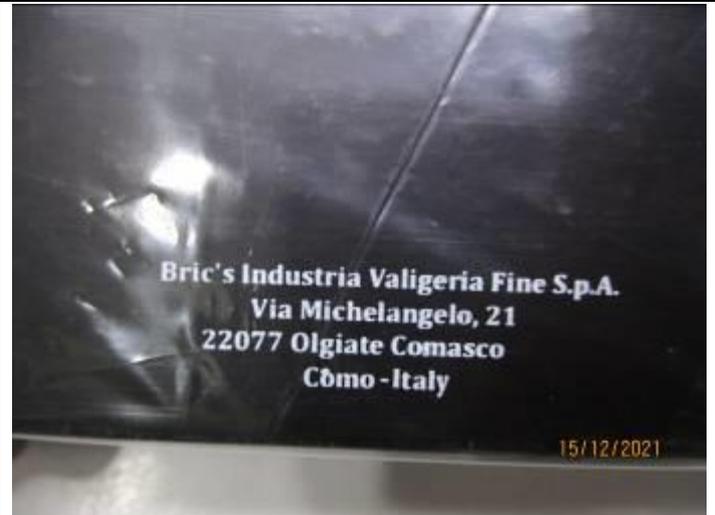
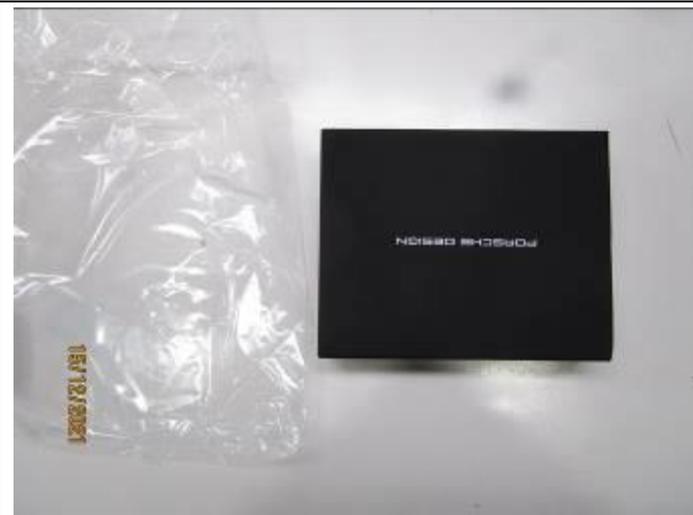
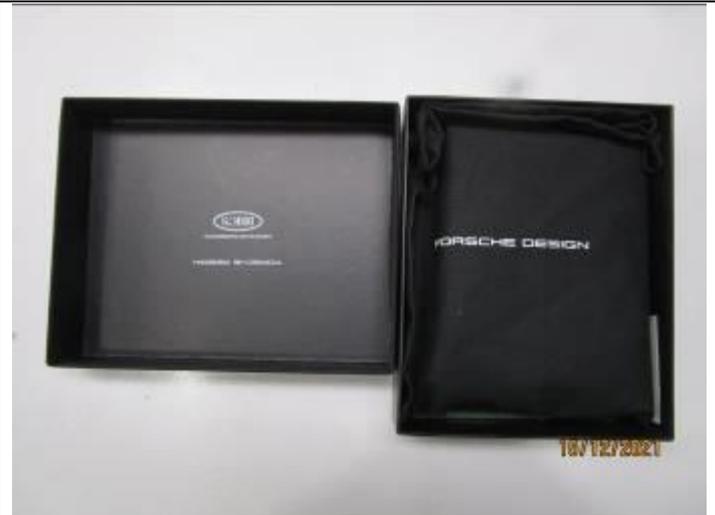
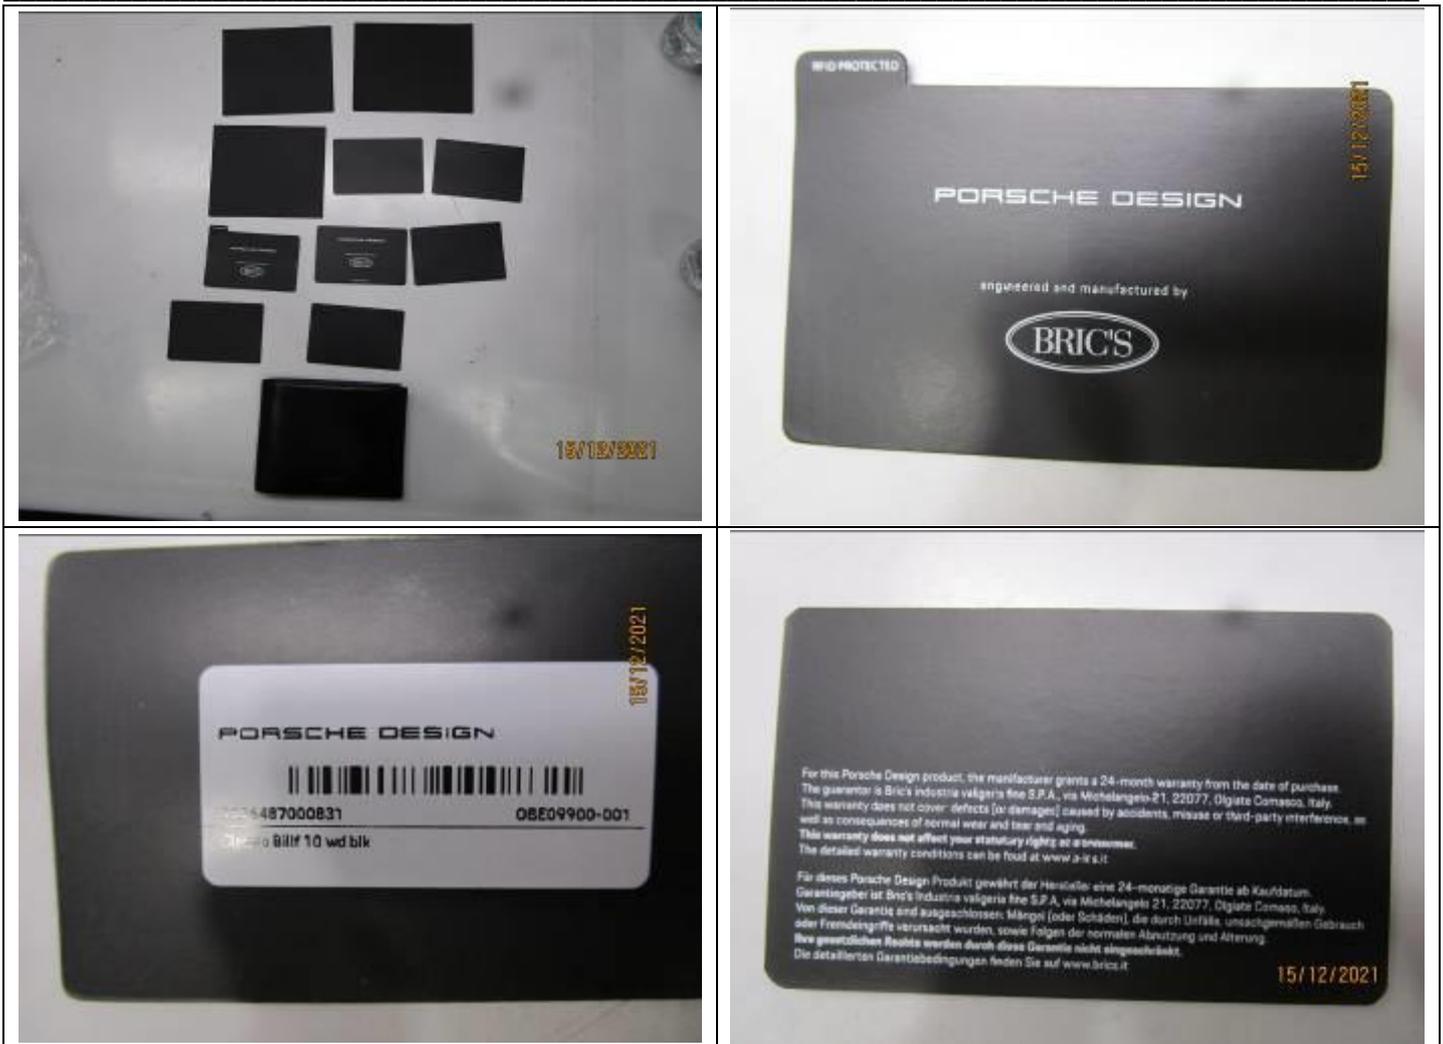
**INDIVIDUAL OR UNIT PACKING**

Expected Result	Result	Comments
<b>Client's Instructions:</b>	Pending	No information or instruction given by the client, below pictures are actual findings of individual packing.
